ADVANCE SERVICE

ADVANCE SUCCESS 2+ Update

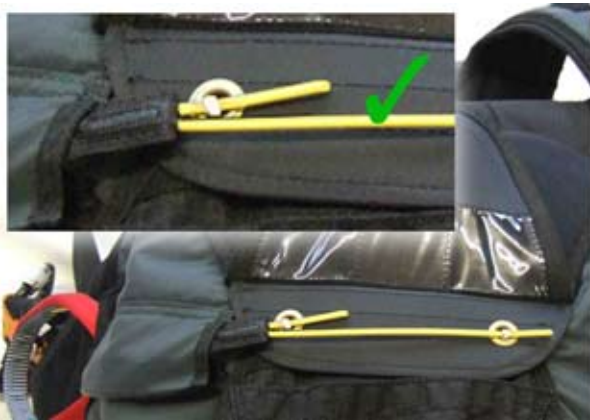
Original reserve handle fitted correctly

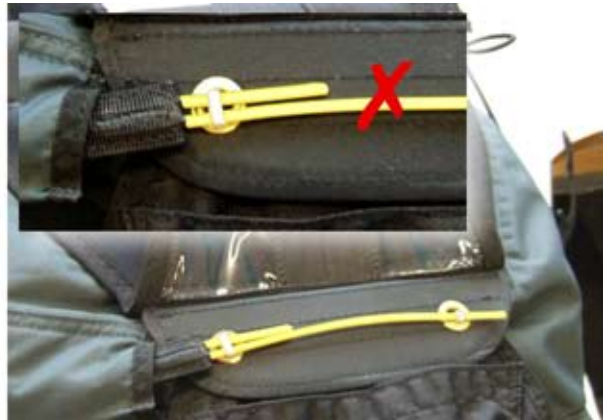
A paraglider pilot inadvertently released his reserve while preparing for takeoff - the outer container opened and the inner container fell out. A friend offered help on the spot and put the reserve back in place. While this was being done the longer of the two yellow reserve handle cables was incorrectly routed through both closure loops. Tests show that successful reserve throwing from this situation can only be achieved by a hard pull in a sawing motion. For a correct installation the short yellow cable should go through the first loop – the longer only through the second.

Original reserve handle fitted wrongly

It is very important that reserve parachutes should only be packed and installed by a qualified person. Packing a reserve starts with an inspection of the components and ends with the secure closing of the outer container, followed by a compatibility check. Packing without reference to the manual or specialised knowledge is negligent!

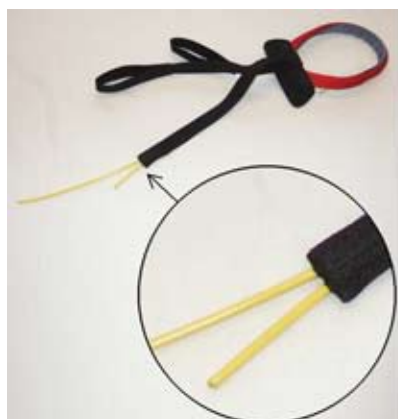
Original reserve handle

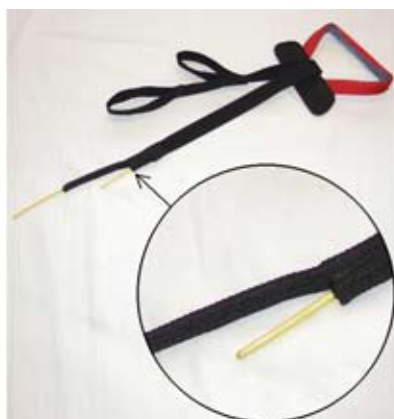
Updated handle

All new Success 2+ harnesses will, with immediate effect, be supplied with a modified reserve handle. This modification prevents the incorrect closure as described above.

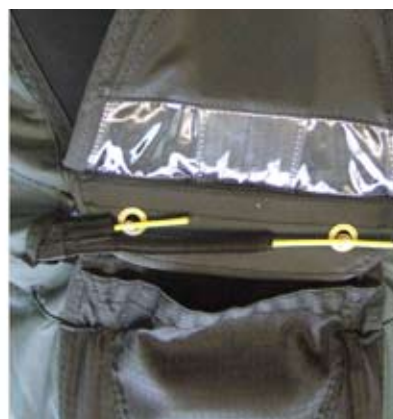
Updated handle fitted correctly
